## Steps for Revitalization in Fukushima

- The progress of the investigation inside Unit 2 PCV (Primary Containment Vessel) at Fukushima Daiichi NPS (Nuclear Power Station) –

Fukushima Reconstruction Promotion Group, METI

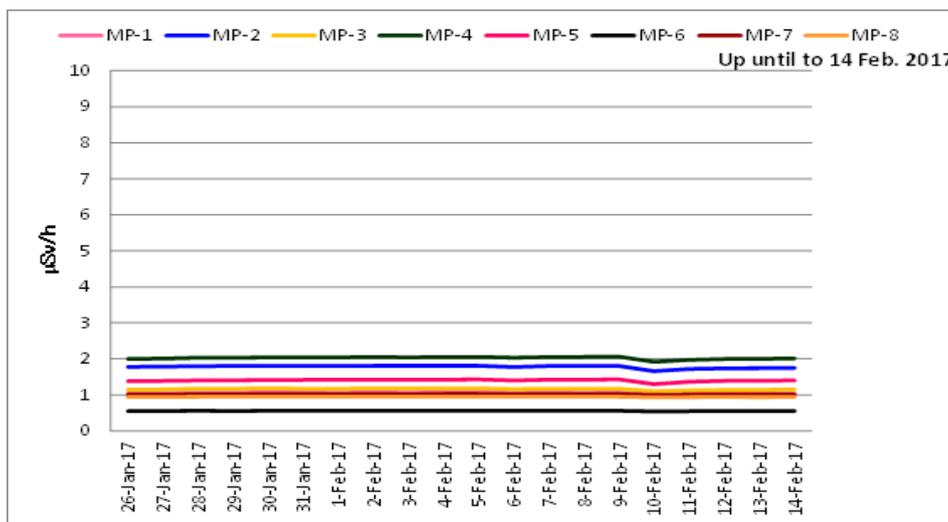
Fig.1 Change of radiation dose at the site boundaries of Fukushima Daiichi NPS

3. The result of this investigation does not mean that some new phenomenon inside the PCV has occurred. Moreover, the inside of the PCV is shielded by thick steel vessel, concrete and zinc-plate inside the building and the gas inside PCV are controlled well. The status inside the PCV is still stable and there are no changes in radiation levels at the site boundaries of Fukushima Daiichi NPS. Through this investigation, there was and will be no effect by the radioactive material to the outside the PCV. (See figure.1)

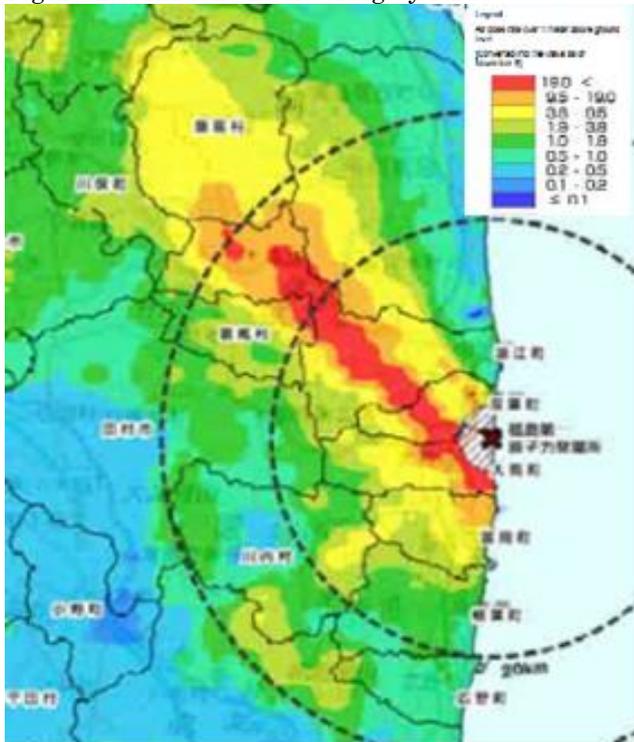
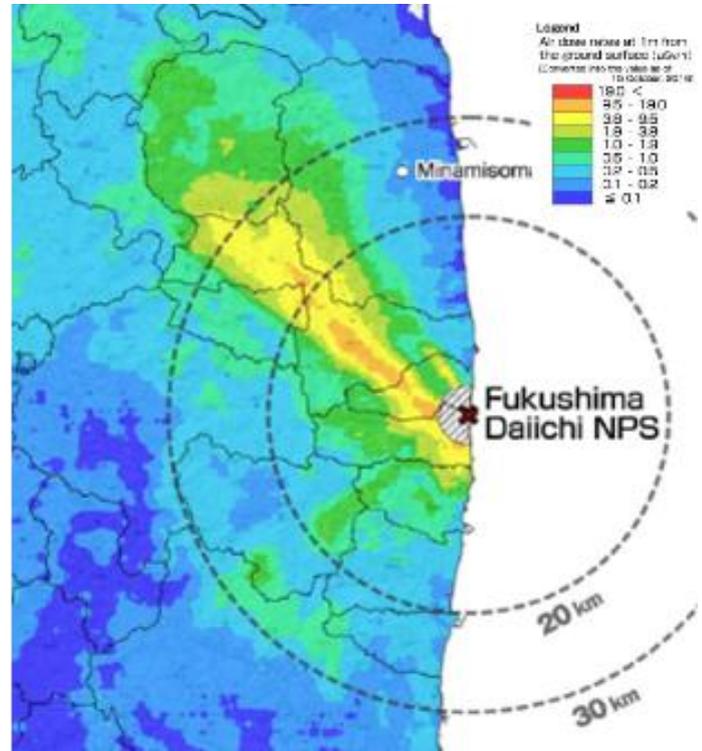
Figure 2. Airbone monitoring by NRA

(5 November 2011)

(15 October 2016)

4. Since the aftermath of the accident of Fukushima Daiichi NPS by the Great East Japan Earthquake, the air dose rate within the 80 km radius of the NPS in October 2016 has decreased up to approximately 70% compared to the air dose rate in November 2011 by the natural attenuation and efforts on remediation. (See figure.2). Lifting evacuation orders are progressing steadily. The evacuation orders were already lifted for Tamura city, Kawauchi village, Naraha town, Kuzuo village, and Minamisoma city. In addition to these areas, the evacuation orders will be lifted for Iidate village and Kawamata town in the spring of 2017. Reconstruction efforts are being accelerated in
