The investigation inside Unit 1 PCV (Primary Containment Vessel) at Fukushima Daiichi NPS (Nuclear Power Station)

Fukushima Reconstruction Promotion Group, METI
Nuclear Accident Response Office, Agency for Natural Resources and Energy

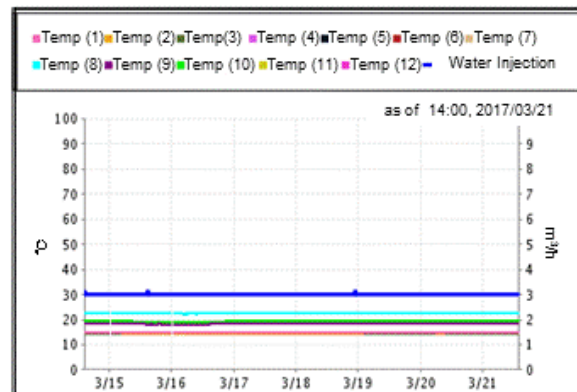
Temperature & Water Injection

Temperatures measured inside the Unit 1 Primary Containment Vessel at Fukushima Daiichi Nuclear Power Station

- Here are the measurement results of temperatures inside the Unit 1 Primary Containment Vessel at Fukushima Daiichi Nuclear Power Station.
- The measured temperatures are within the past fluctuation range, indicating the stable condition of the vessel.

Temperature Unit: °C , Water Injection Unit: m³/h

Temperature (1)	Temperature (2)	Temperature (3)	Temperature (4)	Temperature (5)	Temperature (6)	Temperature (7)
15.0	14.8	14.6	14.8	14.7	14.6	14.6
Temperature (8)	Temperature (9)	Temperature (10)	Temperature (11)	Temperature (12)	Water injection	
22.8	18.6	19.5	-	-	3.0

(as of 14:00, 2017/3/21 about 14~ 23°C)

There have been no changes in the temperature and pressure inside PCV and the reactor maintains a stabilized condition. The result of this investigation does not mean that some new phenomenon inside the PCV has occurred. (See figure.1-1) Moreover, the inside of the PCV is shielded by thick steel vessel, concrete and zinc-plate inside the building. In addition, there are no significant changes in radiation levels of monitoring posts and dust monitoring at the site boundaries of Fukushima Daiichi NPS. Through this investigation, there was and will be no effect by the radioactive material to the outside the PCV. (See figure.1-2)

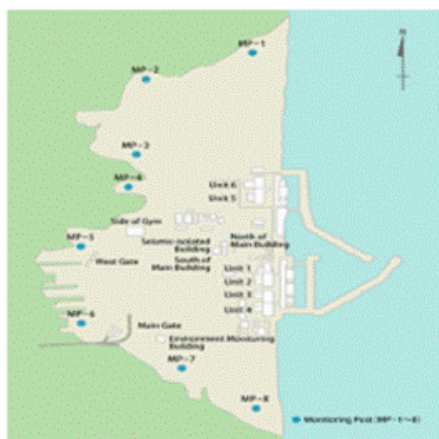
Monitoring points

Monitoring post (MP1 - MP8)

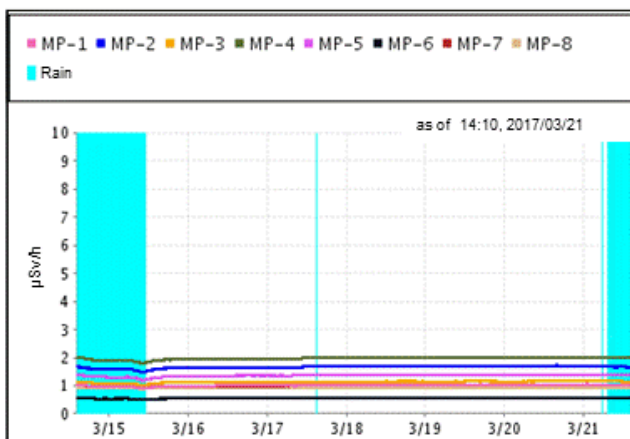
Radiation dose

Radiation Dose measured at Monitoring Post of Fukushima Daiichi Nuclear Power Station

- Here are the measurement results of airborne radiation doses at the monitoring posts (MP1-8) on the premises of Fukushima Daiichi Nuclear Power Station.
- The measured radiation doses are within the past fluctuation range and no significant changes have been detected.

MP Unit: μSv/h Wind Velocity Unit: m/s

MP-1	MP-2	MP-3	MP-4	MP-5	MP-6	MP-7	MP-8	Wind Direction	Wind Velocity	Rain
1.017	1.652	1.131	1.976	1.361	0.549	1.001	0.929	Southeast	2.6	Yes

(as of 14:10, 2017/3/21 about 0.5~2.0 Bq/cm³)

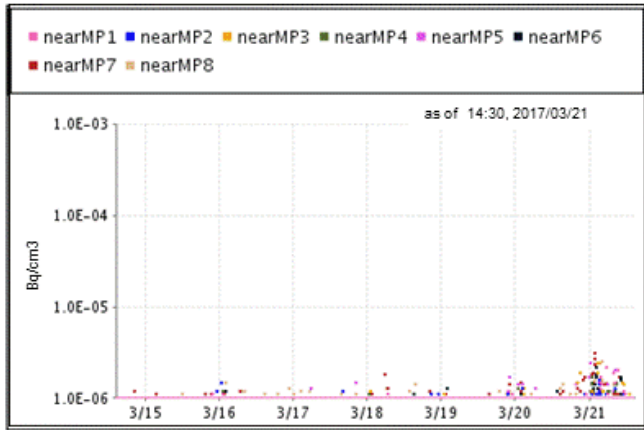
Radioactive concentration

Radioactive Concentration measured at Dust Monitors near the Site Boundary of Fukushima Daiichi Nuclear Power Station

- Here are the measurement results of airborne radioactive concentrations near the monitoring posts (MP1-8) at the site boundary of Fukushima Daiichi Nuclear Power Station.
- The measured radioactive concentrations are within the past fluctuation range and no significant changes have been detected.

Dust Monitor Unit: Bq/cm³ Wind Velocity Unit: m/s

nearMP1	nearMP2	nearMP3	nearMP4	nearMP5	nearMP6	nearMP7	nearMP8	Wind Direction	Wind Velocity
1.0E-06	1.0E-06	1.0E-06	1.0E-06	1.0E-06	1.0E-06	1.0E-06	1.0E-06	east - southeast	0.9

(as of 14:30, 2017/3/21 about 1.0E-06 Bq/cm³)

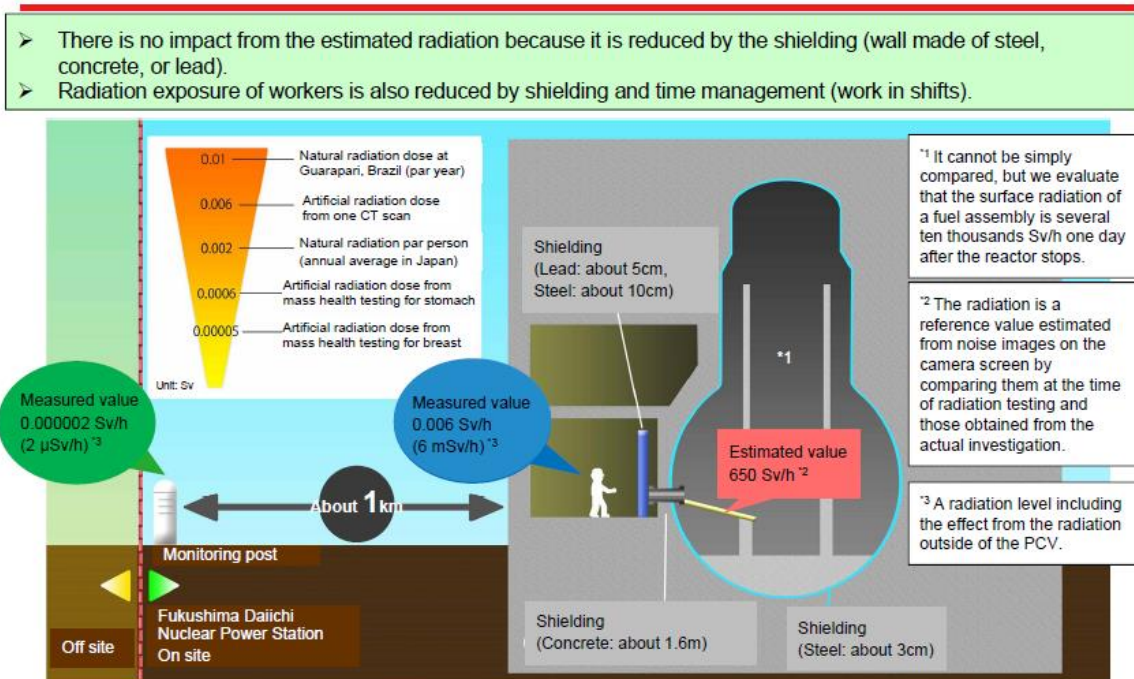
1. Unit 2 Primary Containment Vessel investigation (estimated radiation)

As a result of the analysis of image by the camera, the fallen grating was confirmed and the radiation dose such as a few dozen to hundreds Sievert per hour was estimated inside the PCV. This result, however, needs to be understood that there might be a large measurement error because it was not an actual measurement. Note that it was obtained that the actual measurement of dose rate as 210 Sievert per hour from the result of the actual measurement of radiation dose on 16th February.

On 30th January in this year, the investigation inside Unit 2 PCV using a camera was implemented by Tokyo Electric Power Company (TEPCO) as a consistent work toward decommissioning of Fukushima Daiichi. TEPCO announced that the deposits on the control rod

drive (CRD) exchange rail and the grating platform (the wire mesh-like scaffold at the directory bottom of the reactor) were found.
